The Redevelopment and Restoration of Selected Trail BMP Features to Provide Environmental, Educational, and Aesthetic Benefits

David N. Myers

University of Maryland College Park, Department of Plant Science and Landscape Architecture

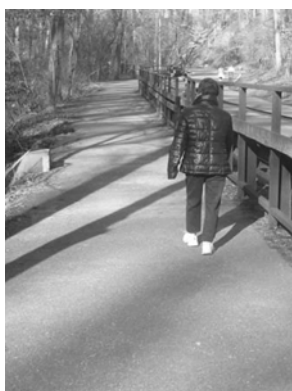
The first opportunity type is the condition where the 2.4m (8 feet) wide trail is co-aligned with the adjacent two-lane roadway. The 2.4m (8 feet) width allows for very safe two-way traffic for multi-modal use during weekdays and Saturday. On Sunday, with the closure of the Piney Branch Parkway to cars, the trail is dominated by more walkers while the roadway accommodates all types of both pedestrians and non-motorized vehicular traffic (tricycles, bicycles, inline skaters, etc.) A heavily compacted median, containing the existing safety barrier is located between the trail and roadway (Figure 3 and Figure 4). The existing barrier is a series of upright steel H-Beams, a vertical metal fence structure with an attached horizontal wood railing (the design of the railing varies from location to location). The existing design did not include water quality goals. Water from the far reach of the road sheet flows

across the road, over the safety median, across the trail, eventually sheet flowing to landscape areas between the trail and Piney Branch Creek. Numerous areas indicate excessive flows and erosion as a result of these conditions.

Figure 3. Example 1 of Co-Aligned Trail and Roadway Condition

Possible solutions involve the construction of an integrated bioretention railing system in the renovated median. The benefits of this location include: 1) immediate capture of road sheet flow, the most significant quality of pervious area and financially supported in the SWAP plan; 2) that root damage is less likely in the median than in the placement of trenching and reservoir located between the trail and creek; and, 3) the prominent visibility for both vehicular and pedestrian users of a retrofitted bioretention safety rail BMP. The uprights could be replaced with water adapted materials (concrete, plastic, etc.). A storage reservoir to accommodate the required catchment area would be positioned both under the median and trail. Underdrains and overdrains would allow for flow over the capacity of the underground retention storage.

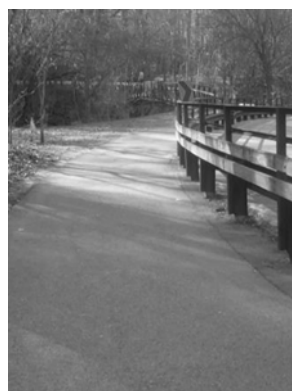
Figure 4. Example 2 of Co-Aligned Trail and Roadway Condition

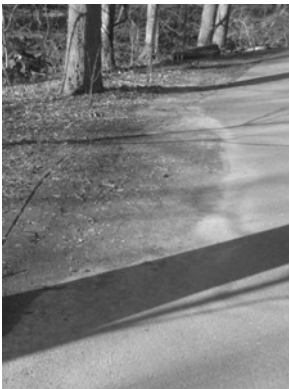
Second opportunities for BMP intervention are site conditions where a more conventional raingarden might be proposed. Figure 5 indicates a typical condition where the proposed raingarden would be located between the trail and the stream. This raingarden would not need an overdrain, thus minimally reducing cost and landscape impact. Figure 6 indicates a typical location where the proposed raingarden location would be located upgrade and on the opposite side of the trail than that of the stream. It would likely require an overdrain to help reduce sheet flow during larger rain events from flowing back across the trail toward the stream. To reduce root damage required of a raingarden installation, soil removal by water might be considered as an alternative to mechanical removal.

Figure 5. Conventional Off-Trail Raingarden Site Condition

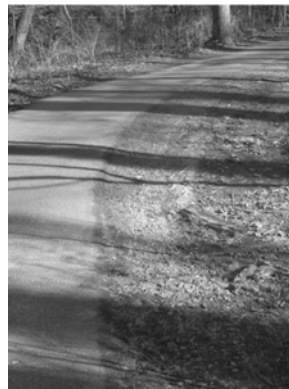
Figure 6. Conventional Off-Trail Raingarden Site Condition

In both cases, these raingardens offer the opportunity to introduce vegetation that might be adaptable to vernal ponds or semi-wet shaded environments. This would be an added benefit in increasing the overall biological diversity and providing additional opportunities to reintroduce native plant education. Raingardens have minimal costs. These BMP opportunities would be a much smaller catchment area than the previously noted BMP. However these features are in line with the catchment areas that have been built and are being proposed. Cumulatively, these catchment areas will make a contribution in providing for more water infiltration and thus water quality improvements.
