# The Restoration of Santa Maria delle Grazie: The New Life of an Ancient Church

Luciana Di Gennaro

Giorgio Frunzio

University of Campania Luigi Vanvitelli, Aversa, Italy

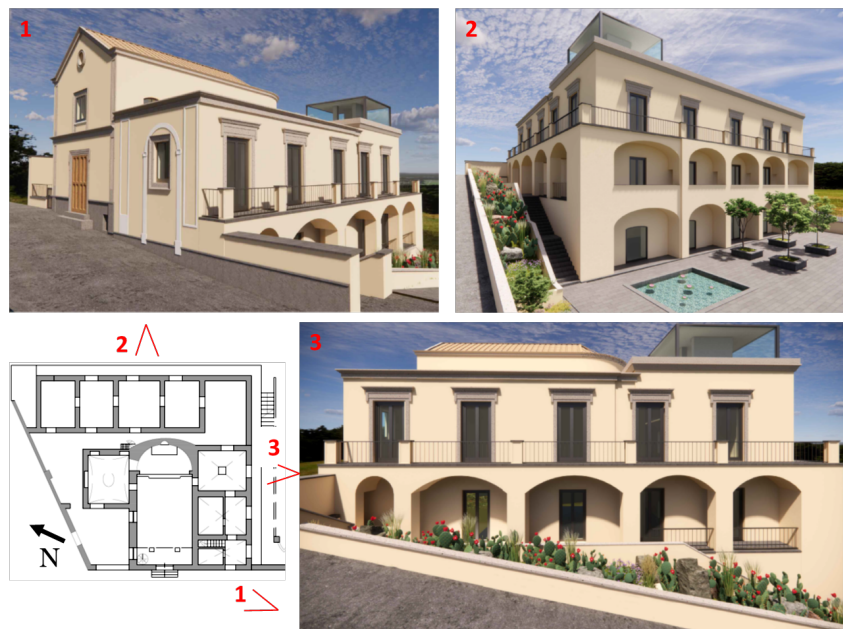
Figure 3: Project rendering (Source: Mancini 2021)

The restoration project follows a route made of conservative strategies combined with breaking choices. While acting with respect to the original shapes and material for the church, arches, vaults and roof, a critical reconstruction will concern the parts that collapsed or are in an advanced state of decay parts . In these portions of the building, the residual original traces do not allow for a faithful reconstruction, therefore. The synergistic work put in place has led to choices that are both respectful of the static and architectural and historical needs and of the present materials, giving life to a new tailor-made project for the monument (Mancini 2021) (Figure 3).

The renovated architectural organism, not emptied of its primitive character, will be used for accommodation and cultural activities. Therefore, a complete redefinition of both horizontal and vertical internal spaces was carried out to allow better usability of the environments and better accessibility of all the areas covered by the intervention. To this end, multipurpose rooms have been provided for cultural, congress, educational and exhibition activities, as well as a series of meeting spaces such as bars and restaurants. The design choices are also dictated by the need to make the architectural complex compatible with the new intended use and compliant with Italian technical regulations regarding accessibility, safety and fire prevention. The plant and functional adaptation will also be carried out concerning the intended use.

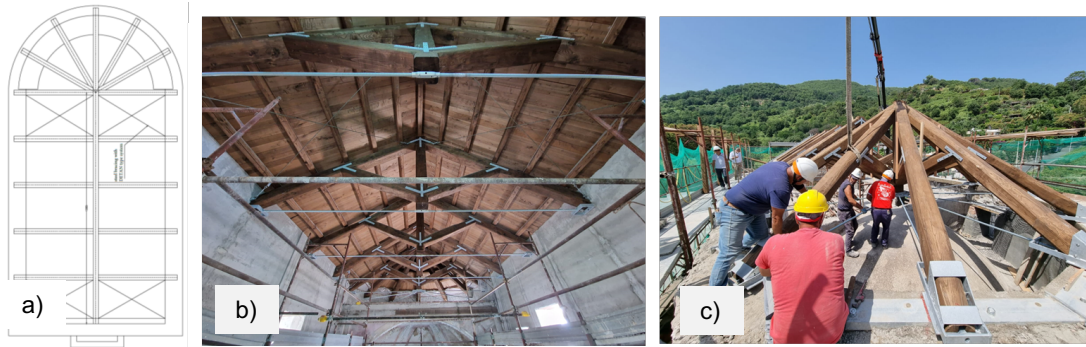
The "umbrella-knot", situated on the roof in correspondence with the passage between the apse and central nave, represents a little prodigy of the workers and is constituted by seven beams in one point converging. The figure below shows the rebuilt roof (Figure 5).

Figure 5: Timber roof structure. a) Roof scheme b) Central nave rood c) "umbrella-knot" (Source: Authors 2022)

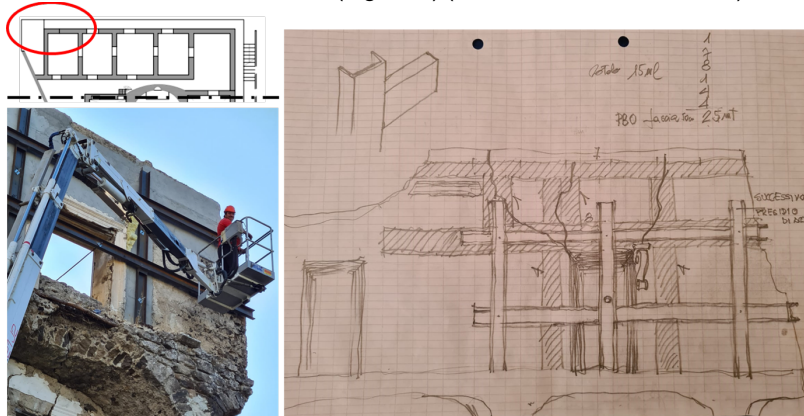
In general, works that involve ancient structure requests an artisanal approach where solutions sometimes have to be found on-site rather than in the conventional workplaces of architects and engineers. That is because cultural heritage often regards buildings with features unknown in advance that trivially don't have right angles and vertical or straight surfaces.... The intervention reported below is an example of this approach born from the in-depth observation on site of the problem encountered in a masonry part at risk of collapse and for whose conservation an ad hoc solution was studied.

Figure 7: Securing unstable Eastern masonry edge (Source: Authors 2022)

The intervention in detail referred to a temporary consolidation with steel beam and PBO strips in a cementitious matrix to avoid collapse preserving the masonry until the stabilising elements such as transverse walls and floors had been built (Figure 7) (Babaedarabad et al. 2014).
