## **Greenway landscape design: River Torrens Linear Park, Adelaide, South Australia - a process rather than an end state.**

Damien Mugavin

*Seoul National University, Department of Landscape Architecture and Rural Systems Engineering.*

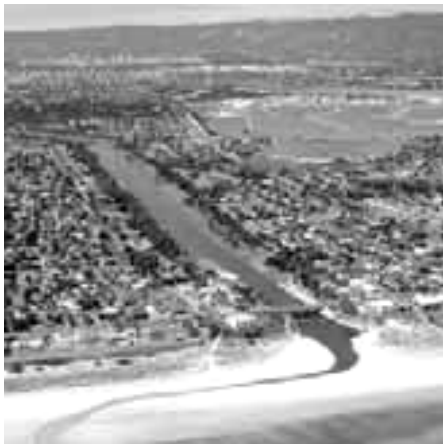
**Figure 1, Breakout Creek Henley Beach South, Adelaide, SA.**

In 1934 the South Australian State Government constructed a flood channel (referred to as Breakout Creek, Fig 1) on the River Torrens at Henley Beach South, to allow river flows through coastal dunes to the sea.

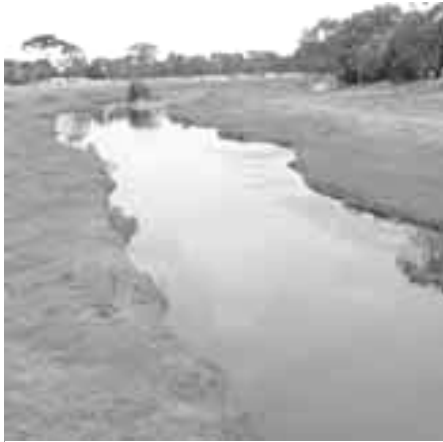
**Figure 3, Breakout Creek, a constructed channel, prior to commencement of in-stream wetland project.**

The Creek had languished as a weed infested drain, with very limited environmental or recreational value. For example, the bed and banks were utilized for horse grazing by local equestrian recreation enthusiasts, with consequent adverse environmental impacts along with restrictions on public access. The almost complete absence of riverine vegetation has adversely affected its habitat value.

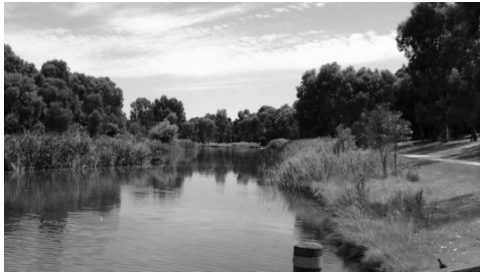
**Figure 4, Breakout Creek Stage 1, view upstream. Design: Taylor Cullity Lethlean.**

Stage 1 of the plan to reinstate the riverine wetlands commenced in 1998 and comprised a 500 metre stretch of the creek, upstream from Henley Beach Road, which has resolved into an environmental and community asset (Mugavin, D., 2004, p 236). Stage 1 was promoted as a demonstration project within a limited area, after a concerted campaign by equestrian enthusiasts against projected limitations on horse grazing. The value of the demonstration project prompted the adoption of Stage 2, re-instatement of in-stream wetlands downstream of Stage 1.

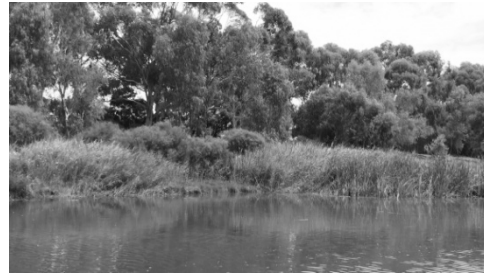
**Figure 5, Breakout Creek Stage 1, Layered vegetation on bank. Taylor Cullity Lethlean.**

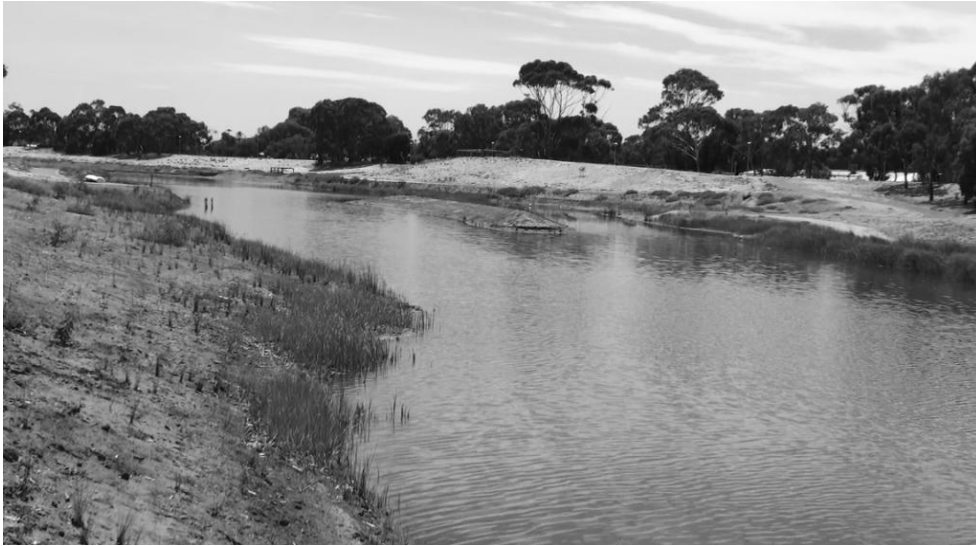
**Figure 7, Breakout Creek Stage 2, downstream of Henley Beach Road.**

Details observable in Figure 7 include:-

- Edge grades that vary to provide shallow reedbed areas of varying water depth;
- Open water areas within meandering channels, providing habitat for avifauna;
- Initial establishment of indigenous reeds including *Schoenoplectus validus* planted on margins of low flow channels to prevent *Typha* (Bulrush) from clogging the channels;
- Island areas at just above water level with reed vegetation including *Bolboschoenus medianus* planted on the crests and other high points;
- Rock lined gravel beaches for erosion protection;
- Wet/dry wetland habitat areas which are subject to frequent inundation in the wet season;
- Existing native trees previously planted and carefully protected during construction of Stage 2.

It may be noted that terrestrial tree, shrub and grass areas are being established at higher elevation.
