Landscape, ecological and visual impacts of a stream restoration in Hungary

Zsombor, Boromisza¹, Attila, Gergely¹, Eszter, Jákli¹, Cai, Xuecheng¹

Szent István University, Department of Landscape Protection and Reclamation¹

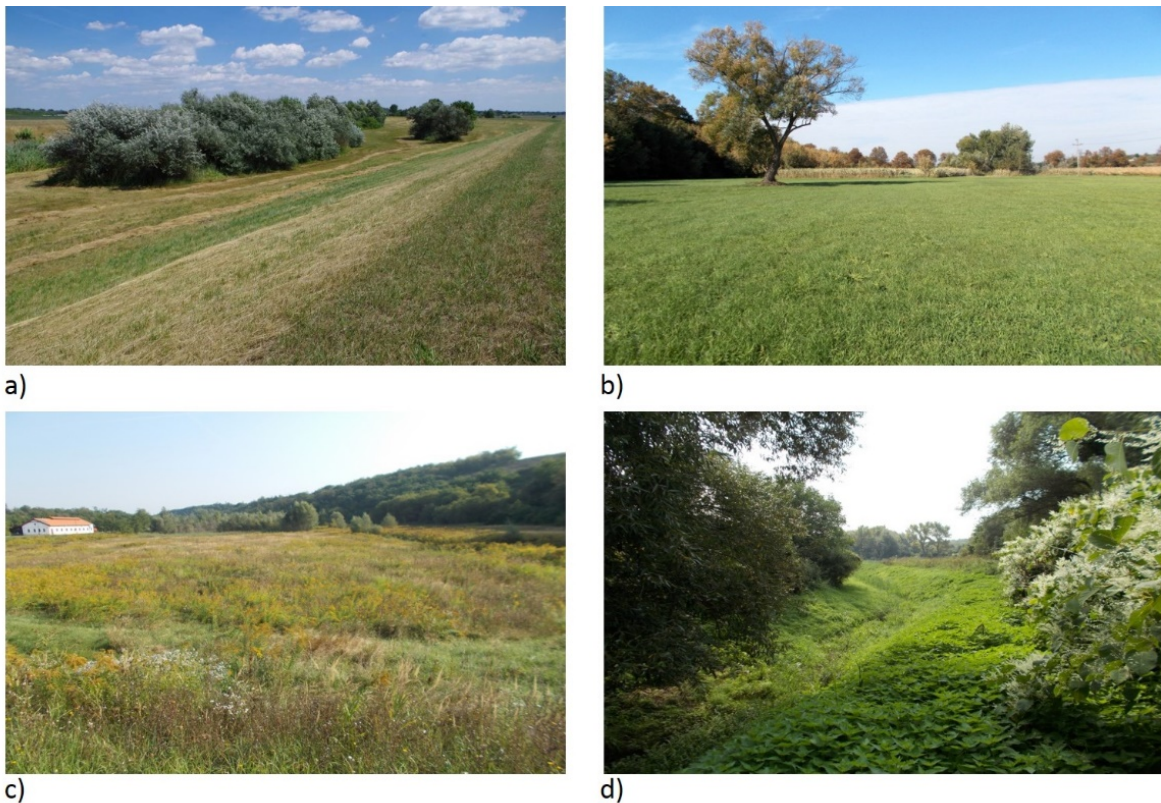
Figure 3. Actual vegetation in the impact area: a) uncharacteristic mesic grasslands and invasive Russian olive stands; b) wet hay meadows and reed beds; c) stands of invasive forbs and pioneer softwood forests; d) fragments of willow-poplar woodlands and ruderal tall-herb vegetation
