## Greenery of the sacral monuments – unique green infrastructure in the urban area: case study Calvary in the Nitra

Mária Bihuňová<sup>1</sup>, Denisa Halajová<sup>2</sup>, Štefan Lančarič<sup>3</sup>  
<sup>1,2</sup>*Slovak University of Agriculture in Nitra, Department of Garden and Landscape Architecture,* <sup>3</sup>*Nitra City Municipality*

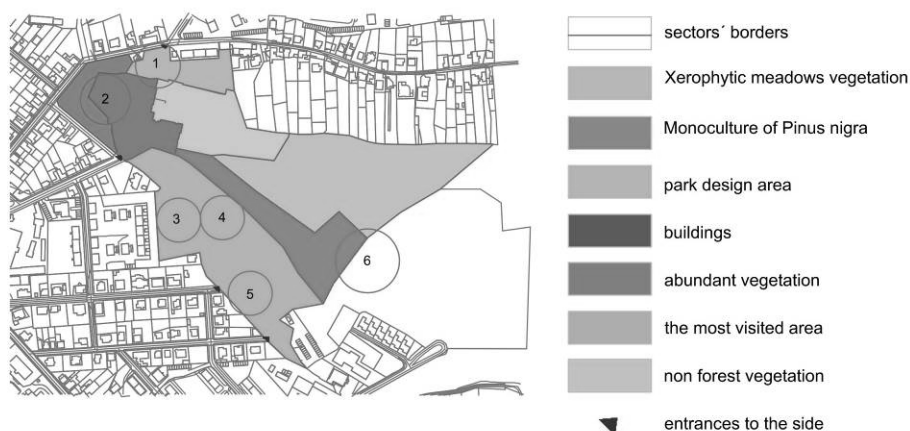
**Figure 3. Category of the greenery and concept of the side**

1 educational trail leads to the Cave of Holy Mary; 2 park design supported by flower beds, trees and with the protection of the views to the city; 3 Children playground designed by simply wooden elements; 4 Fire place and open meadow; 5 Sport/Fit trail; 6 Climbing rock

The landscape concept “*Living in the wood*” was chosen as the suitable proposal for revitalisation of the site. We have proposed 3 main zones: 1. *Representative entrance zone*, 2. *Zone of leisure and recreation*, 3. *Sport zone*.

The first zone will be equipped with more benches to sit, places to stop and learn some historical facts and remarkableness of the site through the educational boards, to perceive the surroundings and views, there will be added flower beds and new plantation of the greenery.

Recreational and leisure zone will be designed as a place for the families with different activities: playgrounds, fire place, benches, and new plantation of the *Rhododendron* sp.

Sport zone offers facilities for sport, recreation, fitness activities. In this part it is necessary to make thinning and new plantation of the trees from the compositional point of view.
