## Challenges of Establishing Green Corridors in the Areas with Agricultural Land Consolidation

Pavel Benka, Jasna Grabić, Atila Bezdan, Milica Vranešević  
*University of Novi Sad, Faculty of Agriculture, Department of Water  
Management*

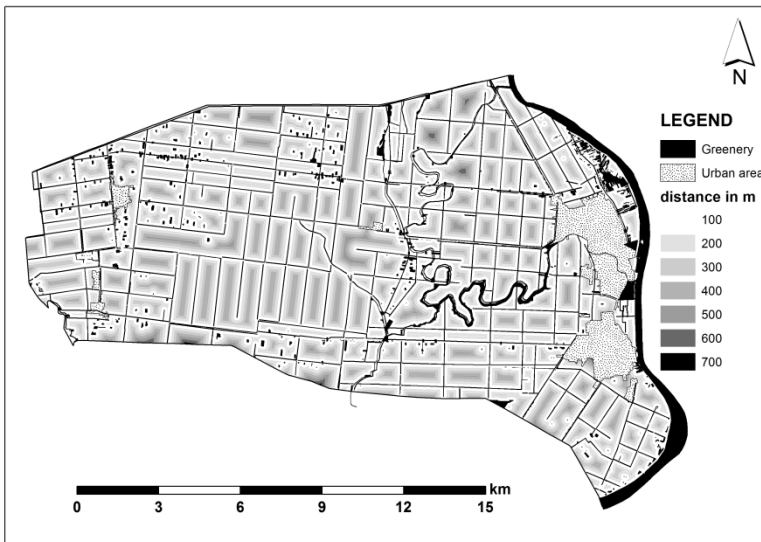
**Figure 2: Distribution of non-forest vegetation according to the project of windshield forest belts**

Besides, the structures would be better connected and more evenly distributed across the area, representing a network of green corridors (Figure 2, Table 1). However, the implementation of the project of agri-protection forest belts would reduce effects caused by the land consolidation. Impairing effects would
